# Intel® 82443MX PCIset

## Specification Update

*April 2001*

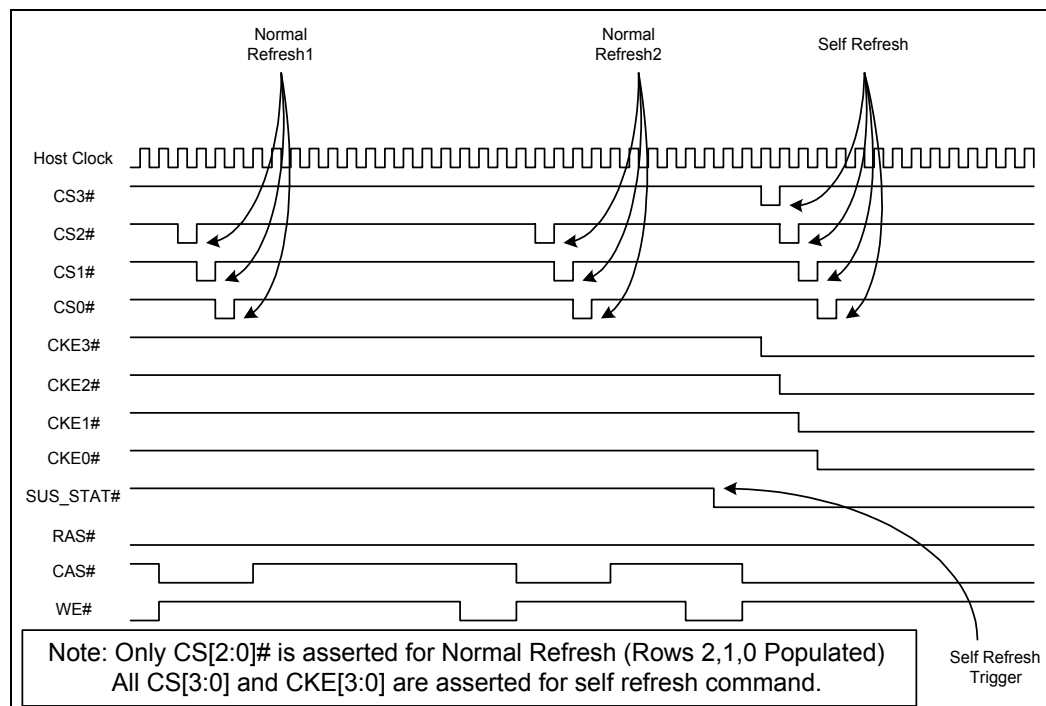
**Figure 1: Successful Self-refresh Entry**

Figure 1 illustrates a successful suspend entry sequence for a system which has rows 0, 1, and 2 populated. Note that for normal refresh, only the chip selects for the populated rows are asserted,

whereas for the self-entry command, all four chip selects are asserted regardless of its population. Assume that dynamic SDRAM power-down feature is disabled. If all four rows are populated, it is impossible to capture this erratum.

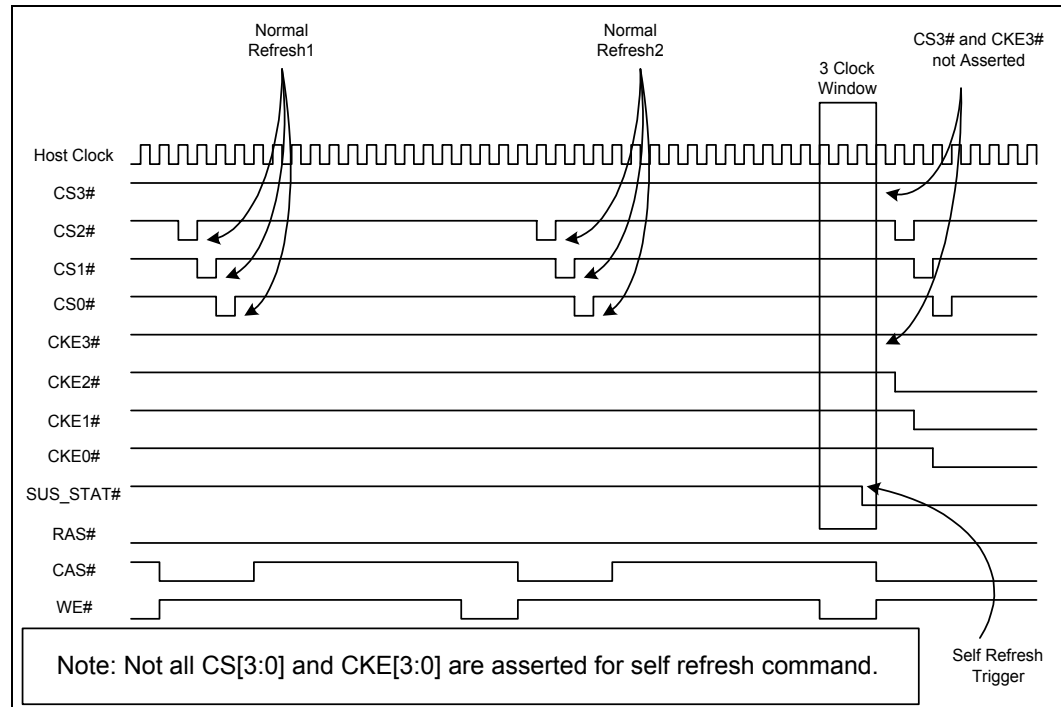
Figure 2: Unsuccessful Self-refresh Entry

An unsuccessful self-refresh will exhibit the following characteristics:

1. SUS\_STAT# assertion is taking place around a normal refresh request.
2. CS# and CKE# signals are asserted only for the populated rows.

Figure 2 illustrates an unsuccessful self-refresh entry sequence. Note that SUS\_STAT# is being asserted approximately the same time that the third normal refresh would have taken place. Since the SUS\_STAT# assertion hits the three host clock window, CS3# and CKE3# do not get asserted during the self-refresh entry sequence.

**Implication:** The system may hang if an unsuccessful self refresh entry sequence occurs.

**Workaround:** Please refer to the SDRAM Suspend Refresh Erratum APM Workaround Write-up, Rev 1.0 for a software workaround solution.
