Intel 430MX PCIsset 82437MX (MTSC)/82438MX (MTDP) and 82371MX (MPIIX) Specification Update

Release Date: December 1997

Order Number 297656-004

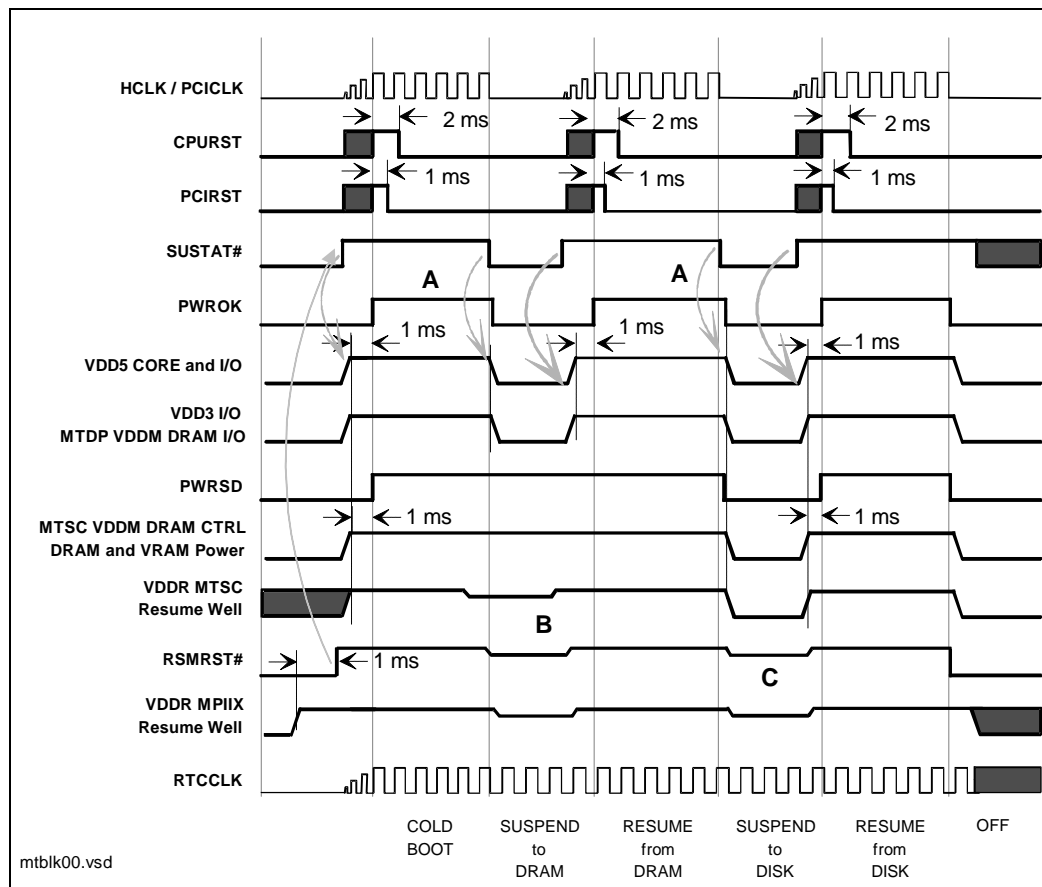
The following diagram provides a valid SUSTAT# signal at cold boot in order to turn on the power plane:
